Safety Inspection Report

Annual Inspection

Hellingly Country Park - Ball Sports Area

25 July 2023

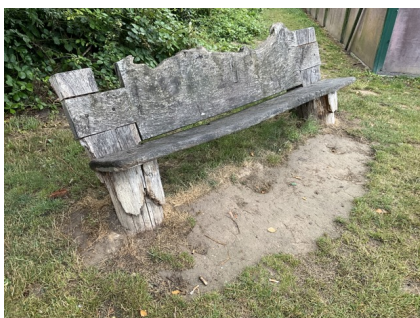
Seating

Timber is decayed.

Replace when necessary.

Risk score:
5

Check on a routine basis.

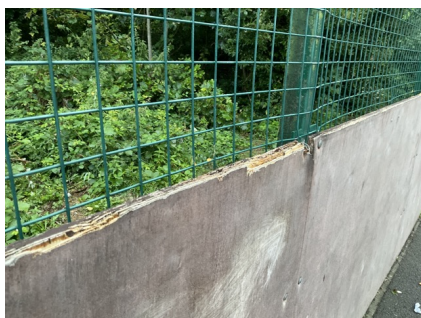
Fencing - Ball Stop Surround

Laminate damaged.

Very minor laminate damage and decay. Monitor and repair as necessary.

Risk score:
3

Rub down and treat damaged edges.

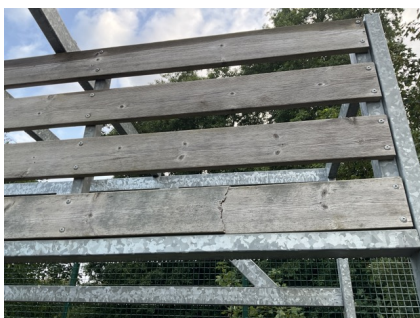
Combination Goal Court

Item broken.

Slat is broken above goal.

4

Replace.

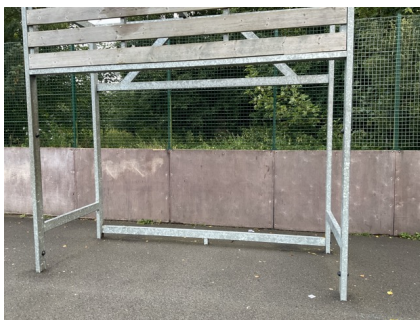
Item has some parts missing.

Ensure that if the nets are replaced, they are not climbable.

6

Replace the missing parts.
