Safety Inspection Report

Annual Inspection

Hellingly Country Park - Senior Play Area

Hellingly Parish Council

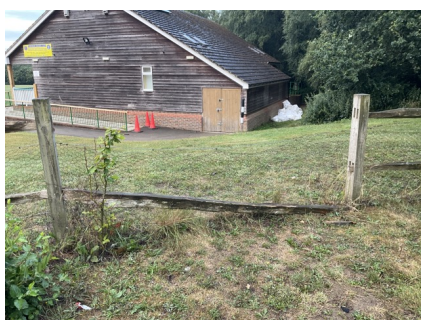
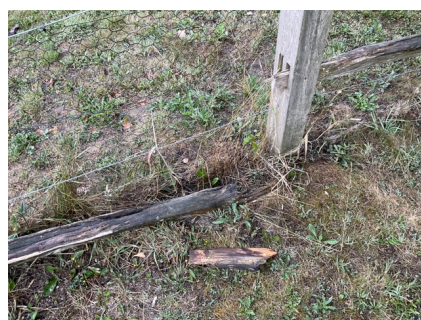
Fencing

Minor repairs are needed.

Top x 1 is missing and lower is damaged. Next to ridged skater.

Risk level:
Low

Risk score:
5

Repair.

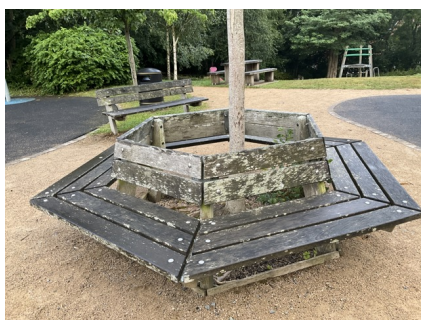
Seating - Tree Surround

The equipment is dirty or algae covered.

Risk level:
Very low

Risk score:
3

Clean off.

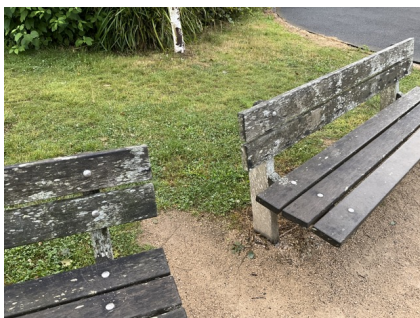
Seating

The equipment is dirty or algae covered.

Risk level:
Very low

Risk score:
3

Clean off.

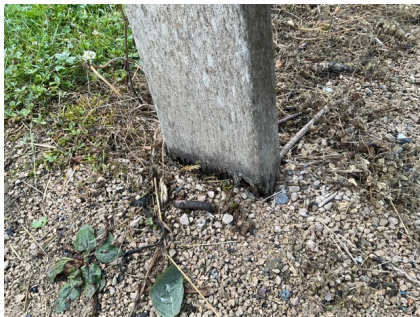
Timber is decayed.

Timber beginning to decay. Monitor.

Low

6

Check on a routine basis.

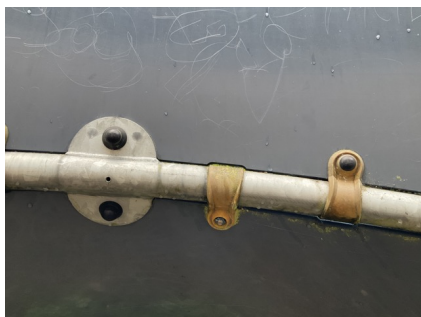
Shelter - Seating

Cap missing.

Roof panel fitting.

Very low

2

Replace.

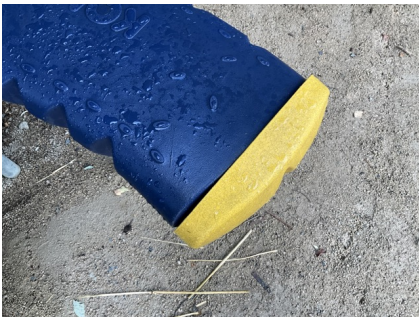
Fixtures loose or missing.

Yellow end can be moved. Tighten connecting bolt.

Low

5

Tighten/replace.

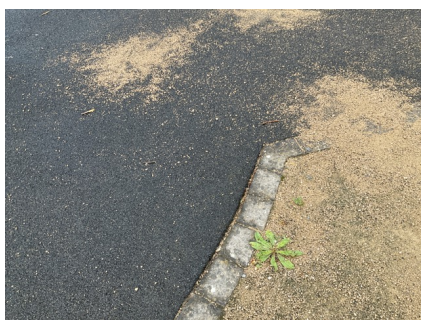
Runway - Rigid - Skate Rider

Shrinkage / separation of the surface. This may give a trip hazard.

Low

5

Re-glue and fill gaps and joints as necessary.

Monitor for development of trip hazards. Repair as necessary.

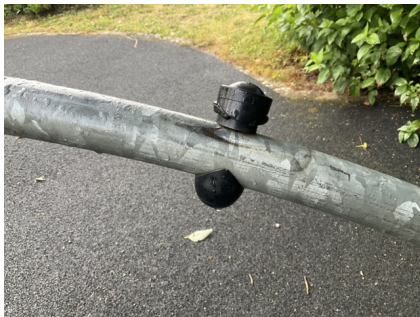
Item is damaged.

Above green triangle.

Low

4

No reasonably practicable action is identified.

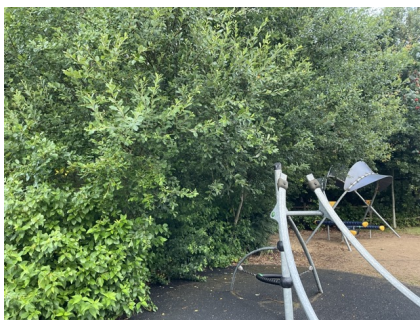
Encroaching vegetation or trees.

Medium

8

Remove.

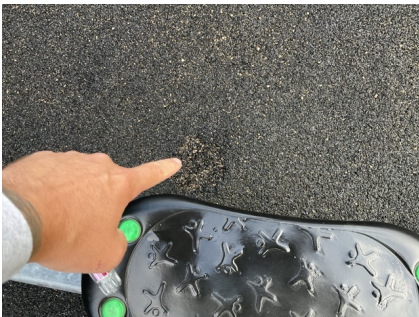
Surface has holes in it.

Small holes forming on the inside of the unit. Repair.

Medium

9

Repair.

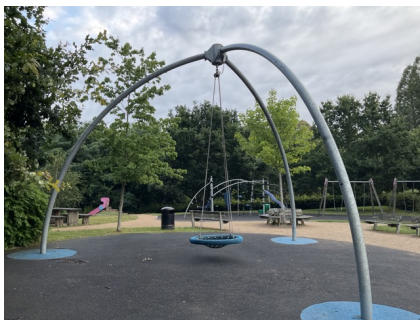
Swing - Basket

The supporting components should be dismantled and inspected according to the manufacturer's instructions. This will need doing on a regular basis, as defined by the manufacturer. This can lead to a high risk if no action is taken.

Please note, it is not possible for the inspector to safely access the most elevated parts of this item for inspection.
Rotational part is not functioning correctly.

Medium

10

Dismantle and inspect according to manufacturer's instructions.

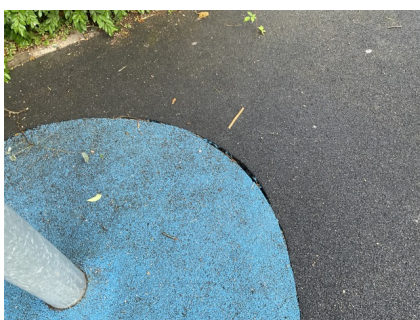
Shrinkage / separation of the surface. This may give a trip hazard.

Low

4

Re-glue and fill gaps and joints as necessary.

Monitor for development of trip hazards. Repair as necessary.

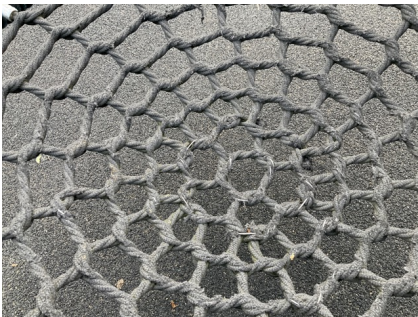
Exposed metal rope core(s).

Monitor for sharp strands breaking free.

Low

5

Read the notes for further action.

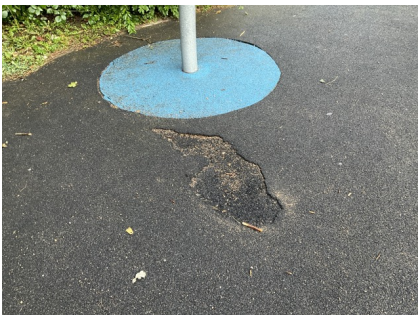
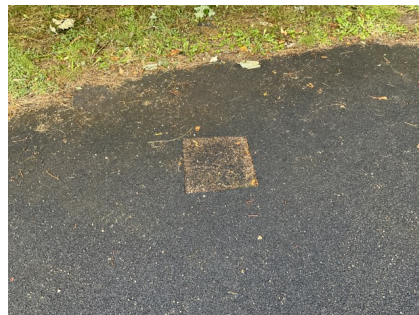
Surface needs repair.

Around support.

Low

6

Repair.

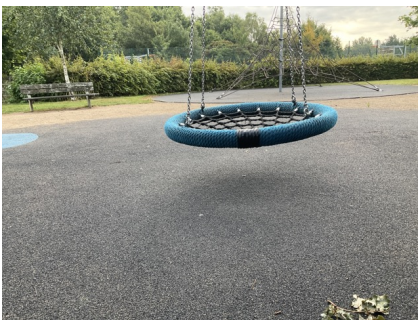
Seat(s) set at incorrect height.

Basket is below 340 mm. Raise to 400 mm.

Medium

8

Adjust to give a minimum of 350 mm clearance for standard seats, and 400 mm for tyres, baskets and other groups seats.

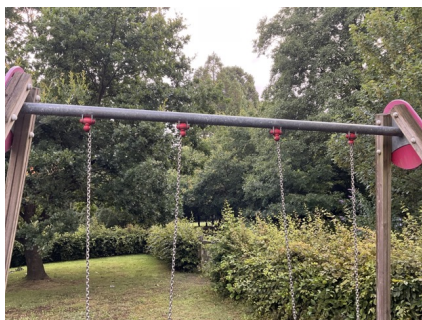
Swing - Junior - 1 Bay 2 Seat (By Fence)

The covers should be removed from the fitting at the top of the chain annually and the shackle bolt should be checked for wear. Check the security of the fittings too.

Low

5

Replace at 70% of original diameter (30% wear).

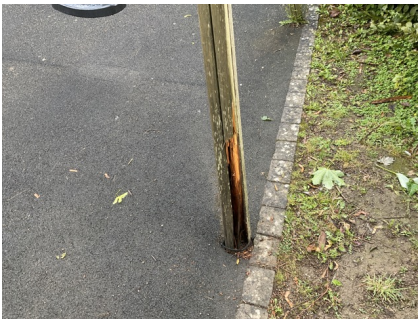
Timber is decayed.

Replace decayed leg.

High

13

Check on a routine basis., We recommend resistance penetration testing to determine the internal condition of the timber. We can undertake this testing at additional cost. Please contact us for details.

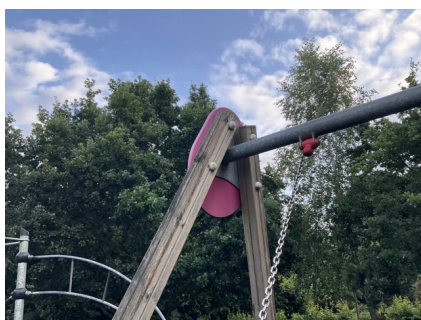
Swing - Junior - 1 Bay 2 Seat (Centre)

Bolt(s) loose.

Supports are loosening at the top fittings. Tighten.

Medium

8

Tighten.

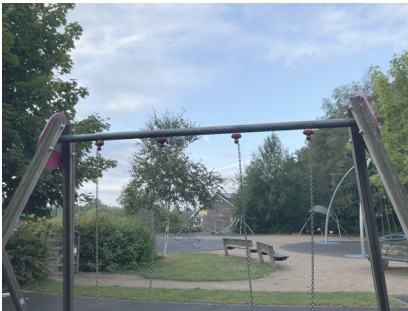
The covers should be removed from the fitting at the top of the chain annually and the shackle bolt should be checked for wear. Check the security of the fittings too.

Low

5

Replace at 70% of original diameter (30% wear).

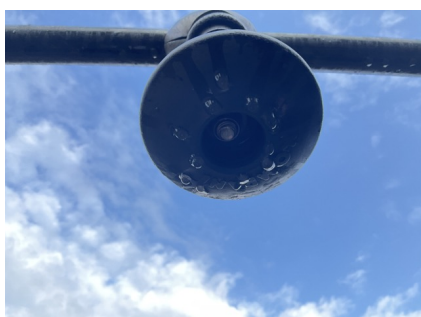
Multiplay - Galaxy

Cap missing.

Under hanging grip.

Very low

3

Replace.

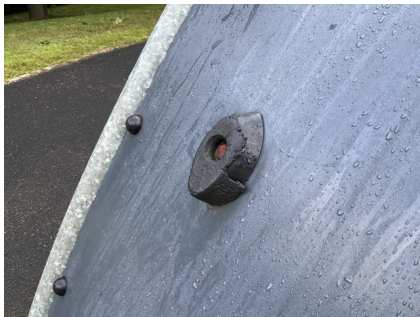
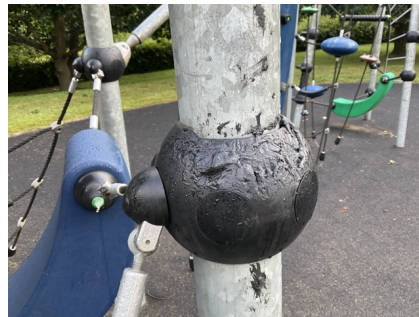
Item is damaged.

Grips and support rubbers. Monitor damage and replace as necessary.

Low

5

Read the notes for further action.

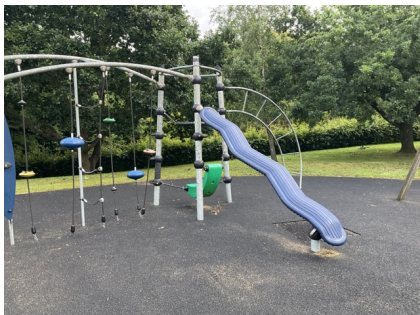
This item is associated with accidents. In RoSPA's opinion, this item may fail the requirements of EN 1176 (4.2.1) in that the movement of the blue climber on this unit is not apparent and foreseeable and could be considered to present a hazard to the user.

Low

6

Read the notes for further action.
